Mass Movements in Great Britain

Chapter 9

A mass-movement site entirely in Pleistocene strata

TRIMINGHAM CLIFFS, NORFOLK (TG 280 390)

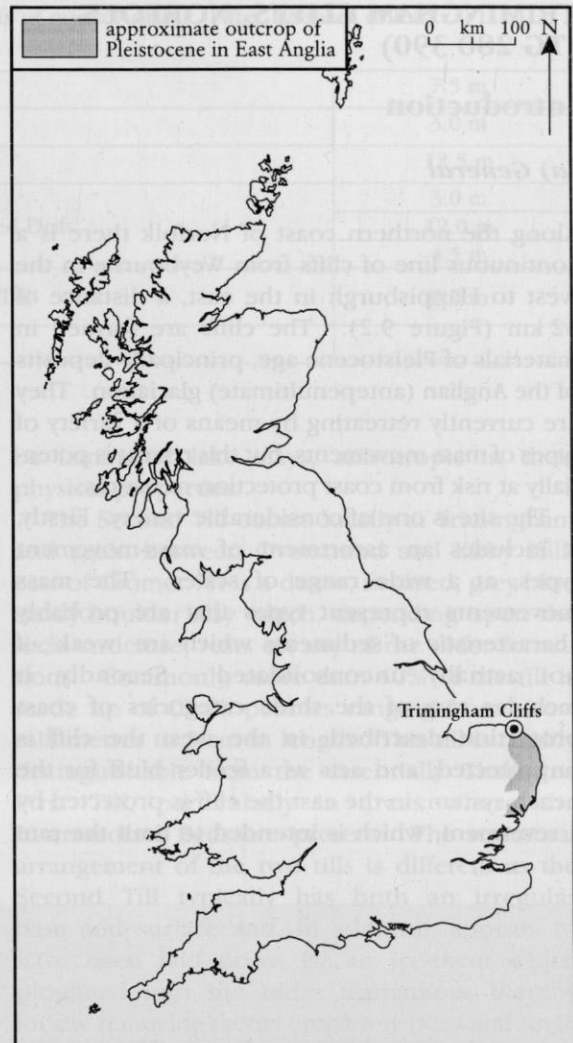
Figure 9.1 Areas of Pleistocene strata in East Anglia (shaded) and the location of the Trimingham Cliffs GCR site, described in the present chapter.

The one mass-movement GCR site entirely in Pleistocene deposits, at Trimingham in Norfolk (Figures 9.1 and 9.2), is a stretch of coastal cliffs undergoing rapid erosion. Such dynamic sites on coastal cliffs are frequently a focus for debate between those wishing to conserve the scientific features and those wishing to protect other interests (for example, where cliff retreat is consuming land that is valuable for some other purpose).

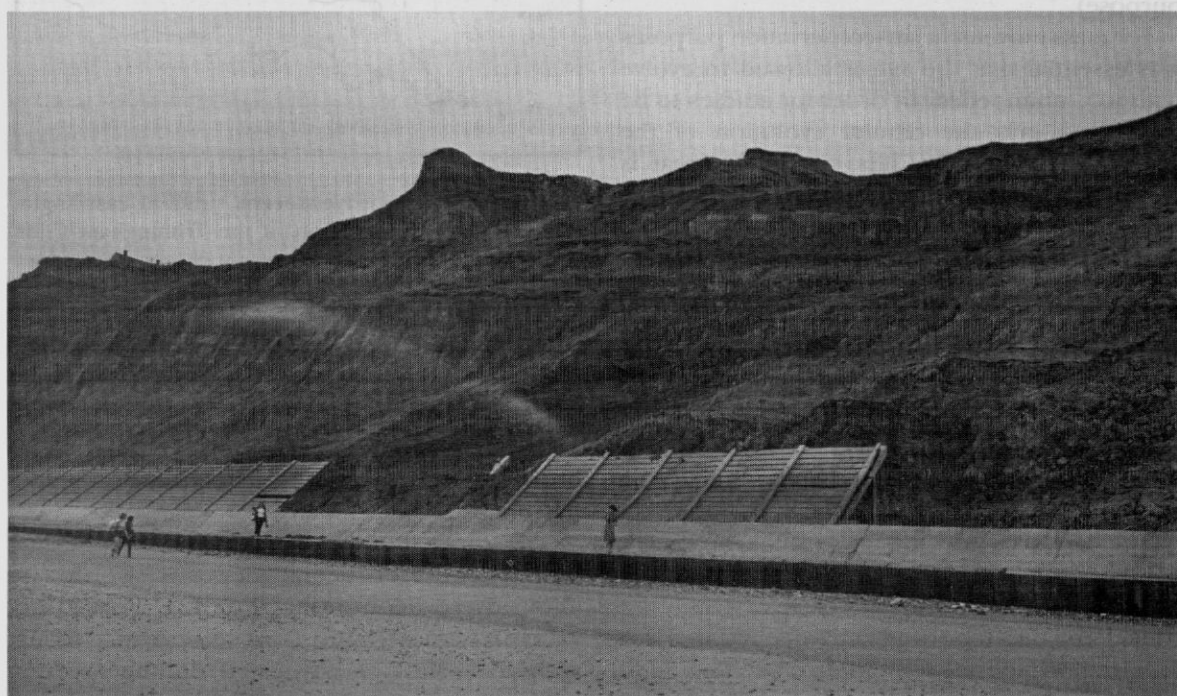
Figure 9.3 Trimingham Cliffs, showing mass movement around and over the revetment. (Photo: R.G. Cooper.)

The breakwaters were never constructed, and the relevant local authority, Norfolk County Council, have allowed the wooden revetment on the beach at Trimingham to fall into disrepair, so its effectiveness as a moderator of wave power has diminished. There is evidence that it had never been effective: the construction of the revetment in 1974 was not without problems. Hutchinson (1983) shows an oblique aerial photograph of the sea defences under construction at Trimingham in 1974. Slope stabilization was not then attempted, on the basis of high cost. The revetment and groynes were installed specifically to check toe erosion. The photograph showed that the line of the revetment works was located too close to the cliff-foot: the excavations needed to permit construction of the revetment stimulated further slides by the concomitant unloading (Hutchinson, 1983). Further consequences of this error in positioning persist to the present: from time-to-time mass movements in the lower part of the cliff give rise to accumulations of cliff materials at the cliff-foot that burst through the revetment (causing damage) or even overtop it (Figure 9.3).

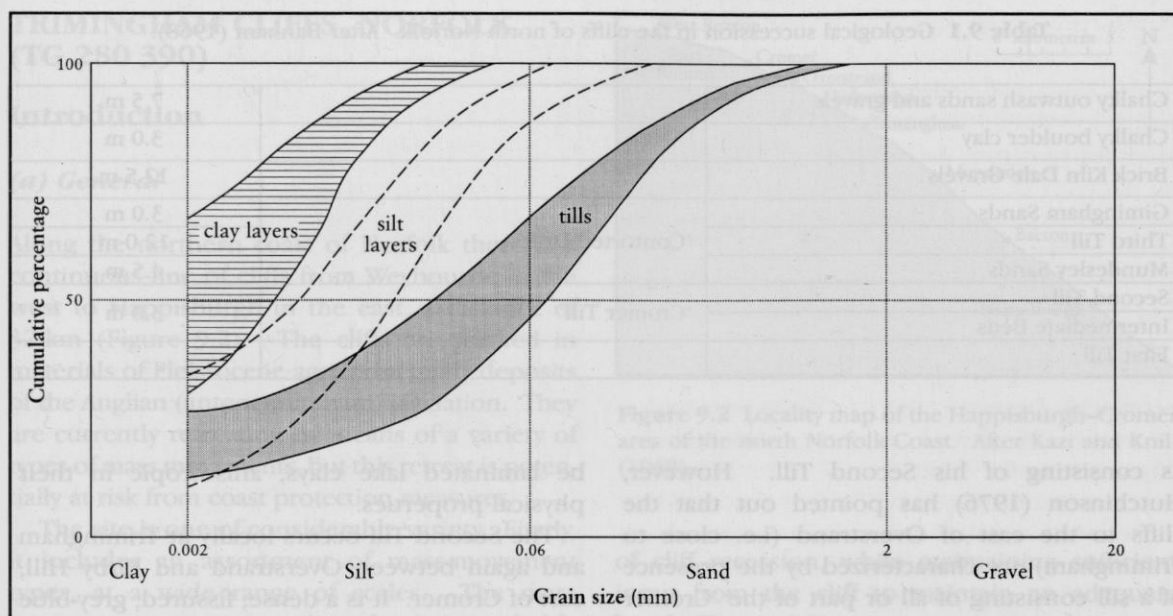
Figure 9.4 Grain-size analyses of tills and the laminated units of the Intermediate Beds. After Kazi and Knill (1969).

Banham's First Till is a dense, fissured, grey or dark-grey sandy boulder clay resting on the Cromer Forest Bed Series, the Leda Myalis Sands or associated deposits. The Intermediate Beds (see Figures 9.4 and 9.5) lying above the First Till have been shown by Kazi and Knill (1969) to

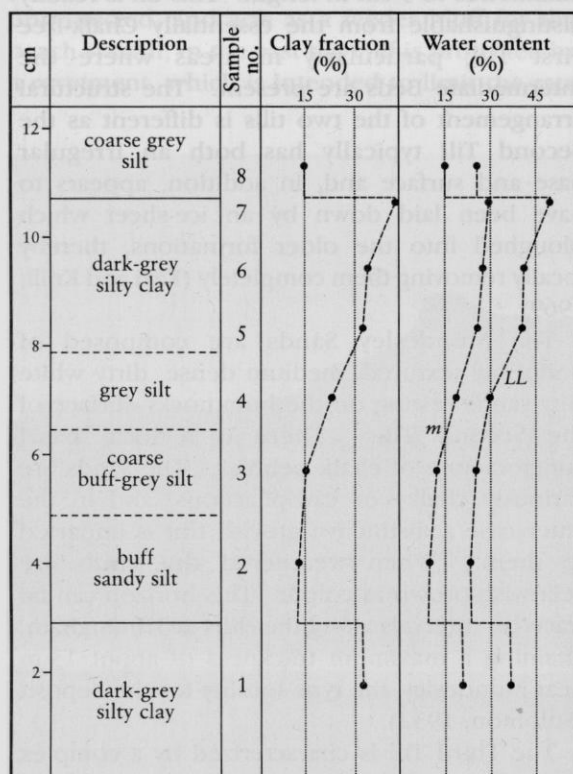
Figure 9.5 Variation of clay content, natural moisture content (*m*) and liquid limit (*LL*) through the individual graded bed in the Intermediate Beds. After Kazi and Knill (1969).

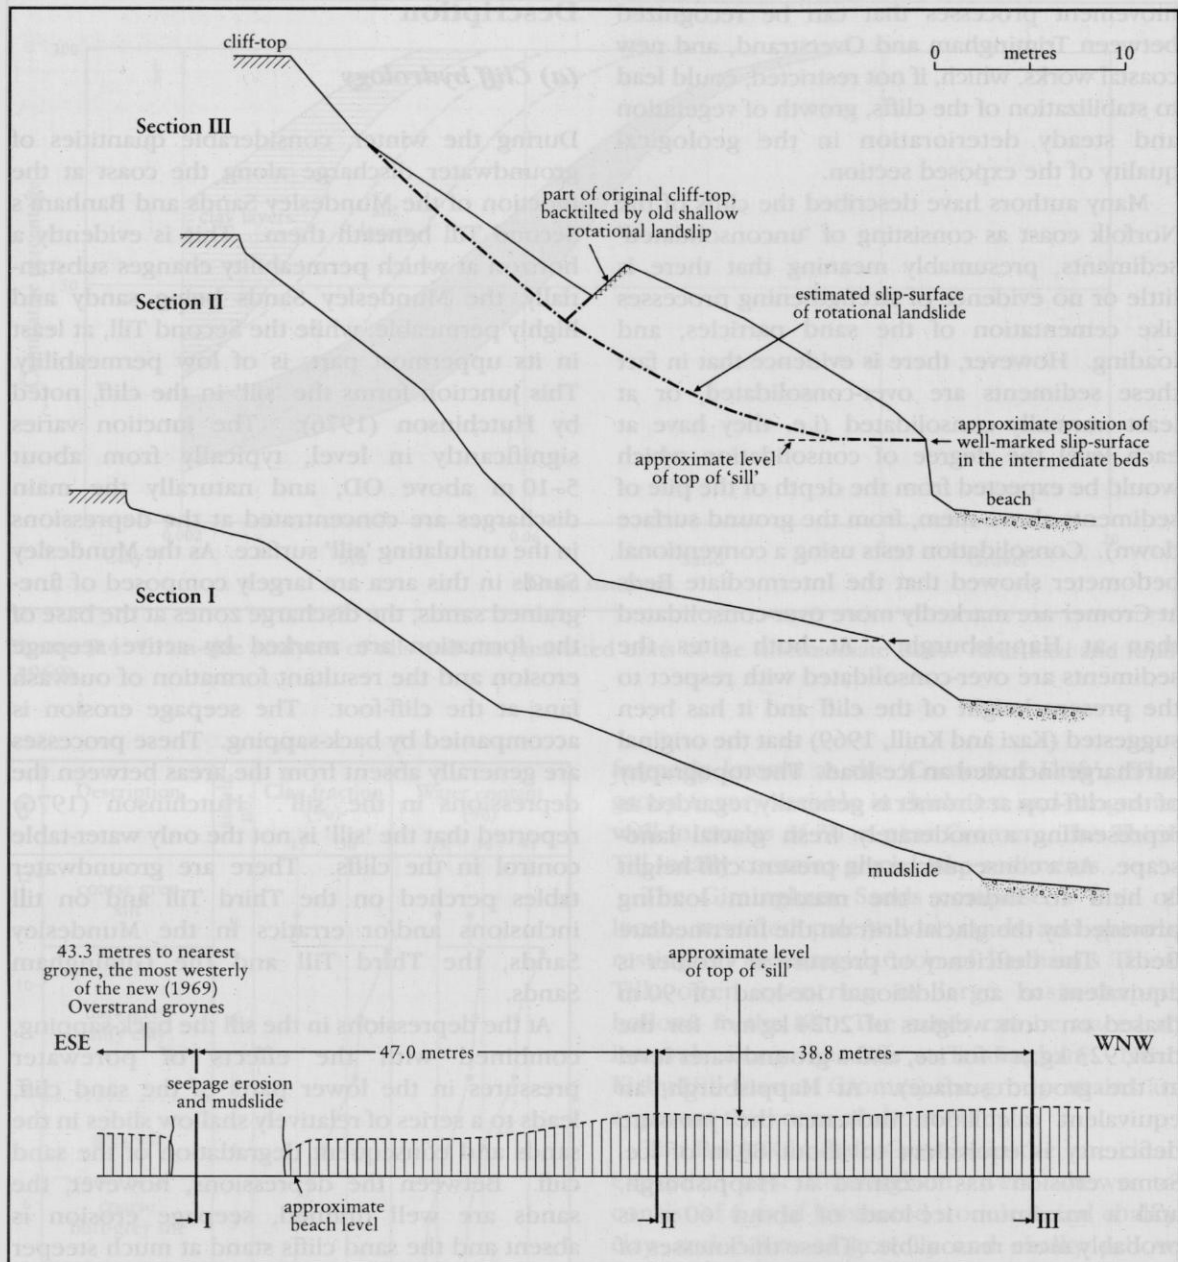
Figure 9.6 Section through the eastern cliffs at Trimingham. After Hutchinson (1976).

At Section I (Figure 9.6) (Hutchinson, 1976), which was located at a depression in the surface of the sill, seepage erosion was very active and had led to the formation of a mudslide of mixed

sand and clay (Hutchinson, 1976). As shown, this had eroded down some distance into the sill. As a result of the back-sapping and resulting shallow slides in the sands, the overall inclination of the cliff was only 24° . In the lower part of the sand cliff the average inclination was about 21° . Such a slope is just stable for an average porewater-pressure ratio, r_u , of 0.37, if the effective shear parameters obtaining are $c' = 0$, $\phi' = 34^\circ$ (Bishop and Morgenstern, 1960).

Section III (Figure 9.6) (Hutchinson, 1976) was located on the crest of an undulation in the sill. Seepage erosion and back-sapping were absent and the sand cliff stood at a much steeper angle, averaging about 31° overall. A rotational slip, involving a slice of the cliff-top, had recently

The cliff profile at Section II (Figure 9.6) (Hutchinson, 1976) is similar to that at Section III in being located at a crest in the undulating sill. Section II represents a later stage of development, however, in which a rotational landslide in the sand, as before exploiting the slip-surface in the Intermediate Beds at its toe, had moved farther down the cliff and spilled over the sill (Hutchinson, 1976). This had left the upper cliff over-steepened, at an average inclination of nearly 45° , and probably soon to be involved in a further rotational slip. Assuming that it was not held up by included masses of till, the steep angle of the sand cliff on Section II provides further evidence for the existence of a cohesion intercept in these sands. This may well be made up from a combination of slight cementation with some capillary porewater tensions. Taking

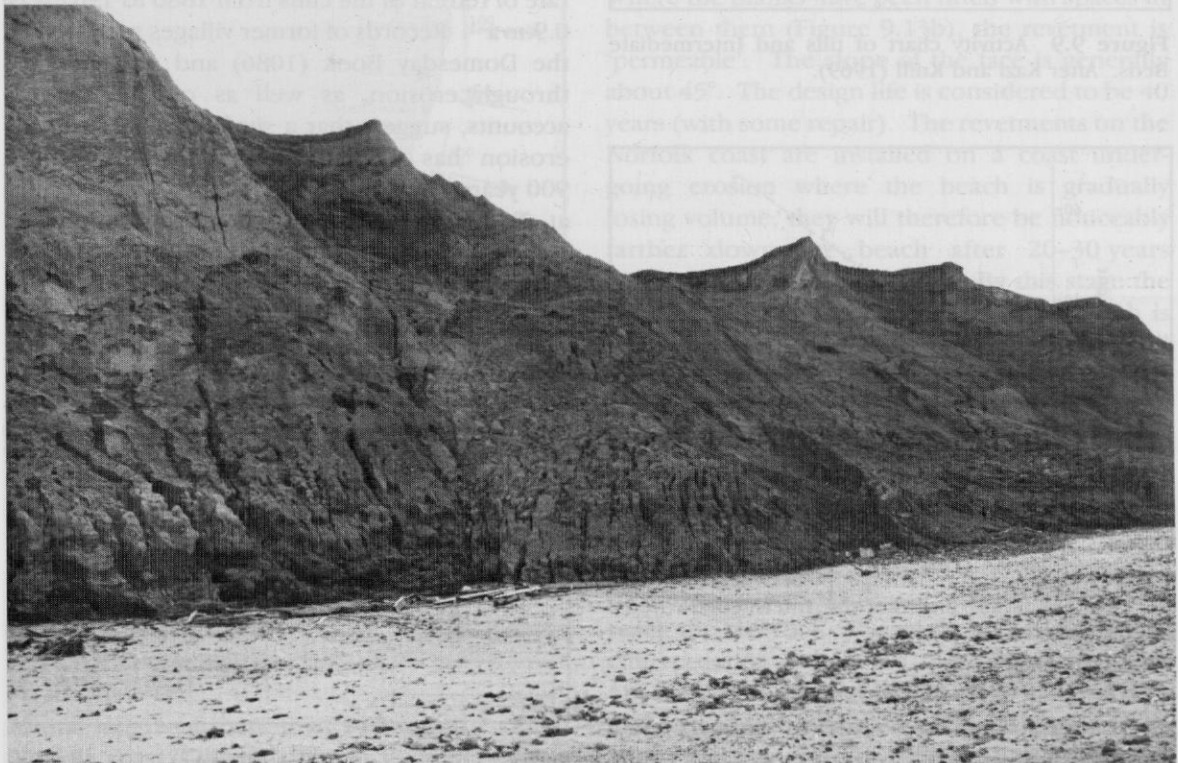
Figure 9.7 Erosion, undercutting, and, in the background, toe erosion at the Trimingham Cliffs GCR site. (Photo: R.G. Cooper.)

The cliffs at Trimingham expose a variety of Pleistocene sediments, and are subject to active coastal erosion (Figure 9.7). This has resulted in extensive slope instability and the development of a wide range of mass-movement features. Kazi and Knill (1969) have observed blockfalls, seepage failures, mudflows, 'sand glaciers' (their term) and deep-seated non-circular slips along this length of coast, and have carried out detailed analysis of the geotechnical properties of the 'Cromer Till' (Figures 9.8–9.10). This rather complex group of inter-related mass movements is responsible for a rate of coastline recession of up to 1.1 m a^{-1} (Hutchinson, 1976). The cliff-top and the cliff-foot are receding at about the same rate, maintaining the overall slope angle.

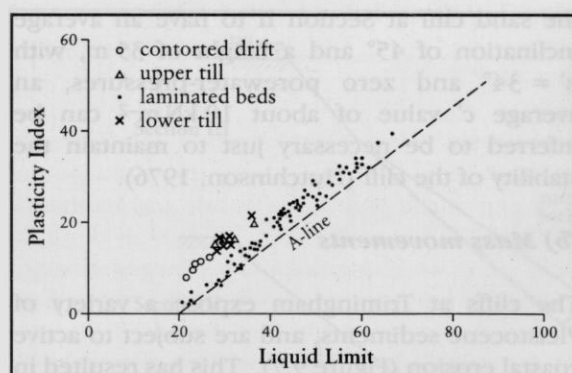
Figure 9.8 Plasticity charts for tills and Intermediate Beds. After Kazi and Knill (1969).

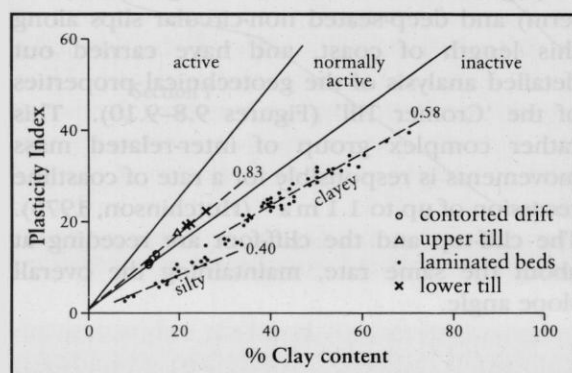
Figure 9.9 Activity chart of tills and Intermediate Beds. After Kazi and Knill (1969).

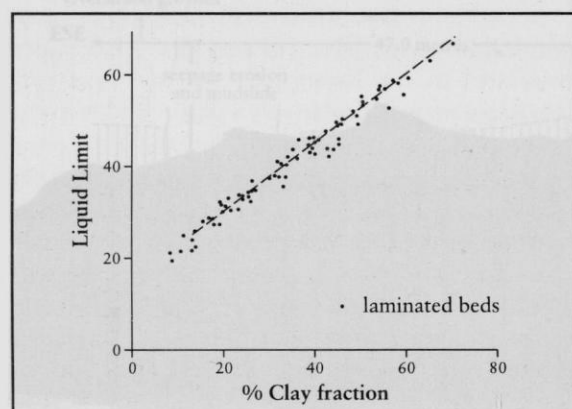
Figure 9.10 The relationship between the clay fraction and liquid limit for the Intermediate Beds. After Kazi and Knill (1969).

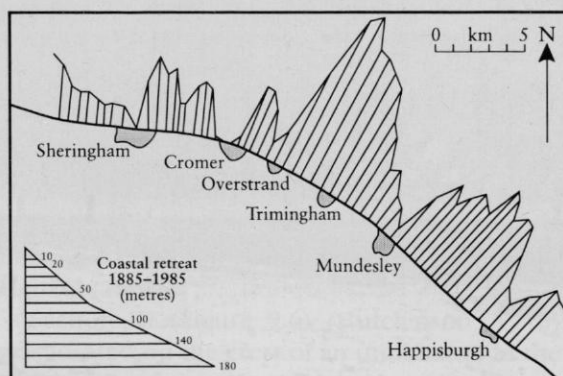
Figure 9.11 Total coastal retreat between 1885 and 1985 based on the First Ordnance Survey at 1:10 560 scale and field survey in 1985. After Clayton (1989).

Taking measurements from published maps, Cambers (1973, 1976) found that the average rate of retreat of the cliffs from 1880 to 1967 was 0.9 m a^{-1} . Records of former villages recorded in the Domesday Book (1086) and now missing through erosion, as well as other historical accounts, suggest that a similar average rate of erosion has persisted for at least the past 900 years. Clayton (1989) showed that the cliffs at Trimingham had the greatest amount of retreat on the Norfolk coast over the 100 years to 1985 (Figure 9.11). The waves incident on the

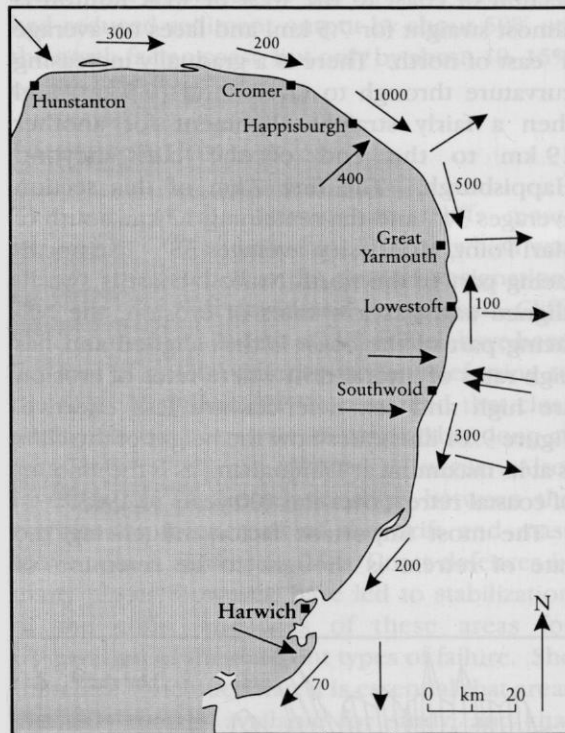
Figure 9.12 Net longshore transport values (m³) for April 1974–March 1975 computed from wave observer data on wave height and direction. Based on Cambers (1976) and Clayton (1980).

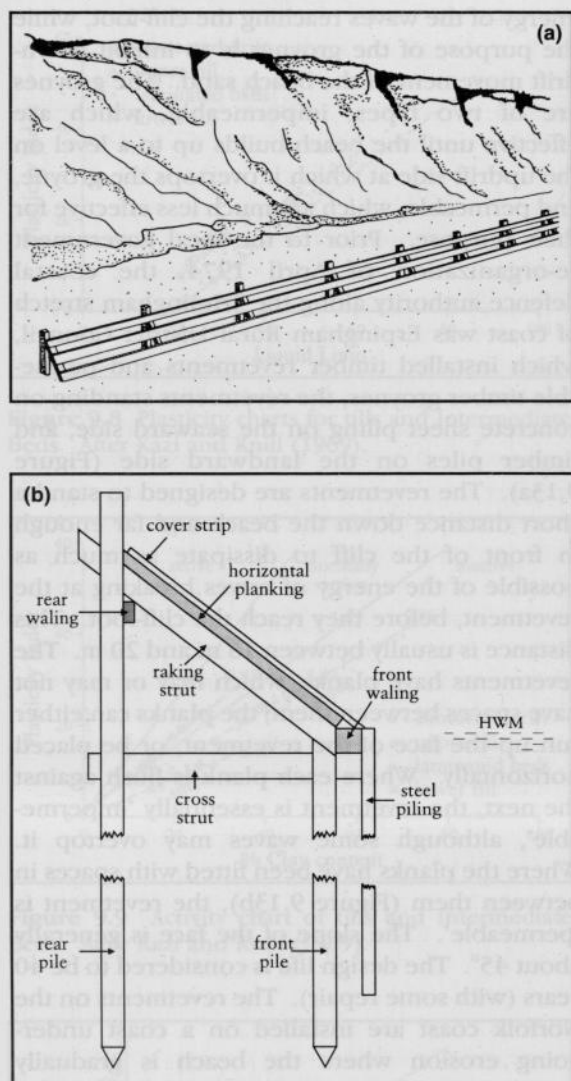
Figure 9.13 (a) Design of the timber revetments used on the Norfolk Coast (after McKirdy, 1990). (b) Design of the timber revetments used at West Runton (after Clayton and Coventry, 1986).

At Trimingham the cliffs are protected by a timber revetment the face of which consists of horizontal slats with gaps in between. This is sufficient to reduce substantially the power of incoming waves, while still allowing waves to reach the cliff-foot. The result is that the rate of cliff recession is lowered, but cliff recession is not halted. It allows the cliff-foot to be eroded by the waves, and a range of mass movements are taking place on the cliff as a result. Although this does not include deep-seated slips, these can be seen in the unprotected stretch of cliffs between

Revetments are seen as 'softer' in character than walls, i.e. less reflective. An experiment was designed by Clayton and Coventry (1986) to measure the effects of reducing the number of planks on a revetment at West Runton. Some stretches of revetment were left with the original maximum of 10 planks, while other lengths had 4 planks; 7-plank stretches provided a physical intermediary between the two. On all of the sections measured, the beach level fell over the three-year period of observations, both behind

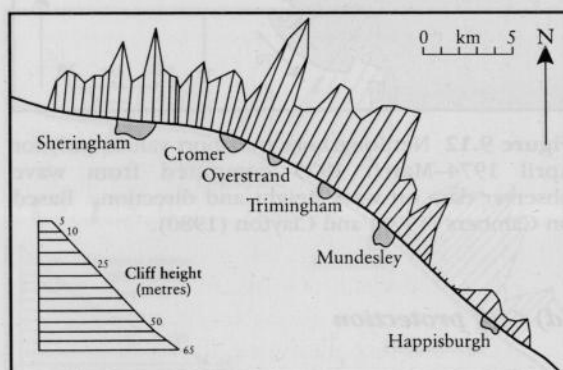
Figure 9.14 The height of the cliff of north-east Norfolk plotted for each measurement cell. After Clayton (1989).
